Sample Report

March 2006

Burdick Bros. Inc.
Quality Service Since 1985

VIBRATION ANALYSIS • LASER ALIGNMENT • DYNAMIC BALANCING

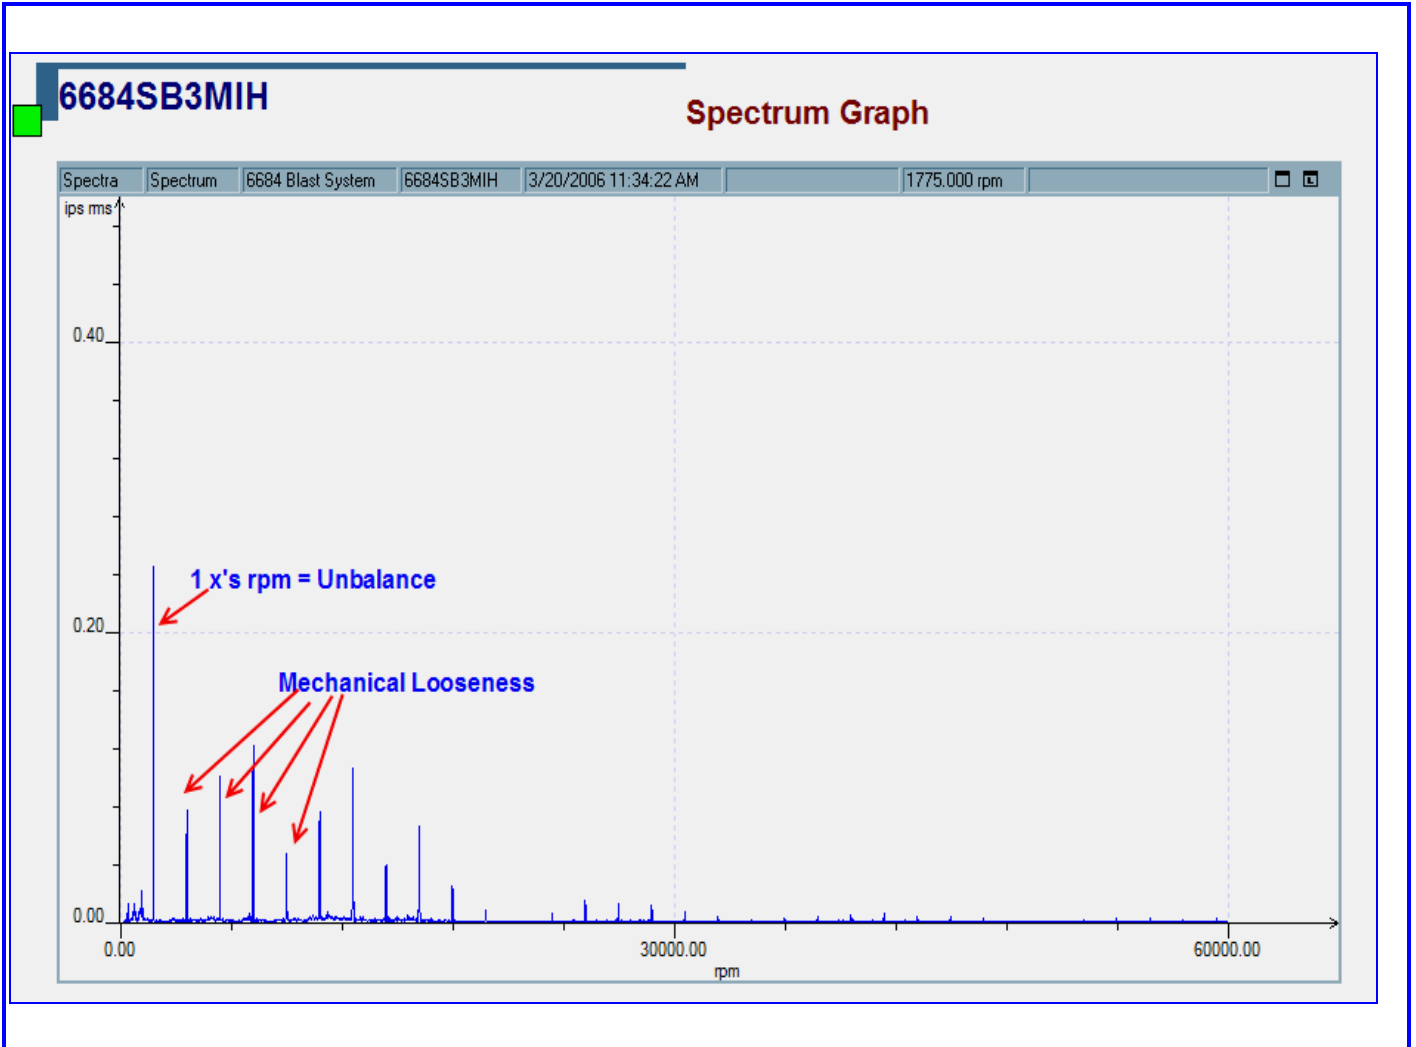
Blast System

- **Blast Cabinet Motor: Elevated Vibration Levels at 1 x's rpm, Indicate Unbalance
- **Shot Blaster Motor #1: Vibration Levels are Within Normal Working Tolerance
- **Shot Blaster Motor #3: High Vibration Levels with Harmonics of Running Speed, Indicating Unbalance and/or Looseness (See 6684SB3MIH Spectrum Graph)

- **Dynamically Balance or Check and/or Replace Blowers on Blast Cabinet and Shot Blast #3
- **Periodic Monitoring

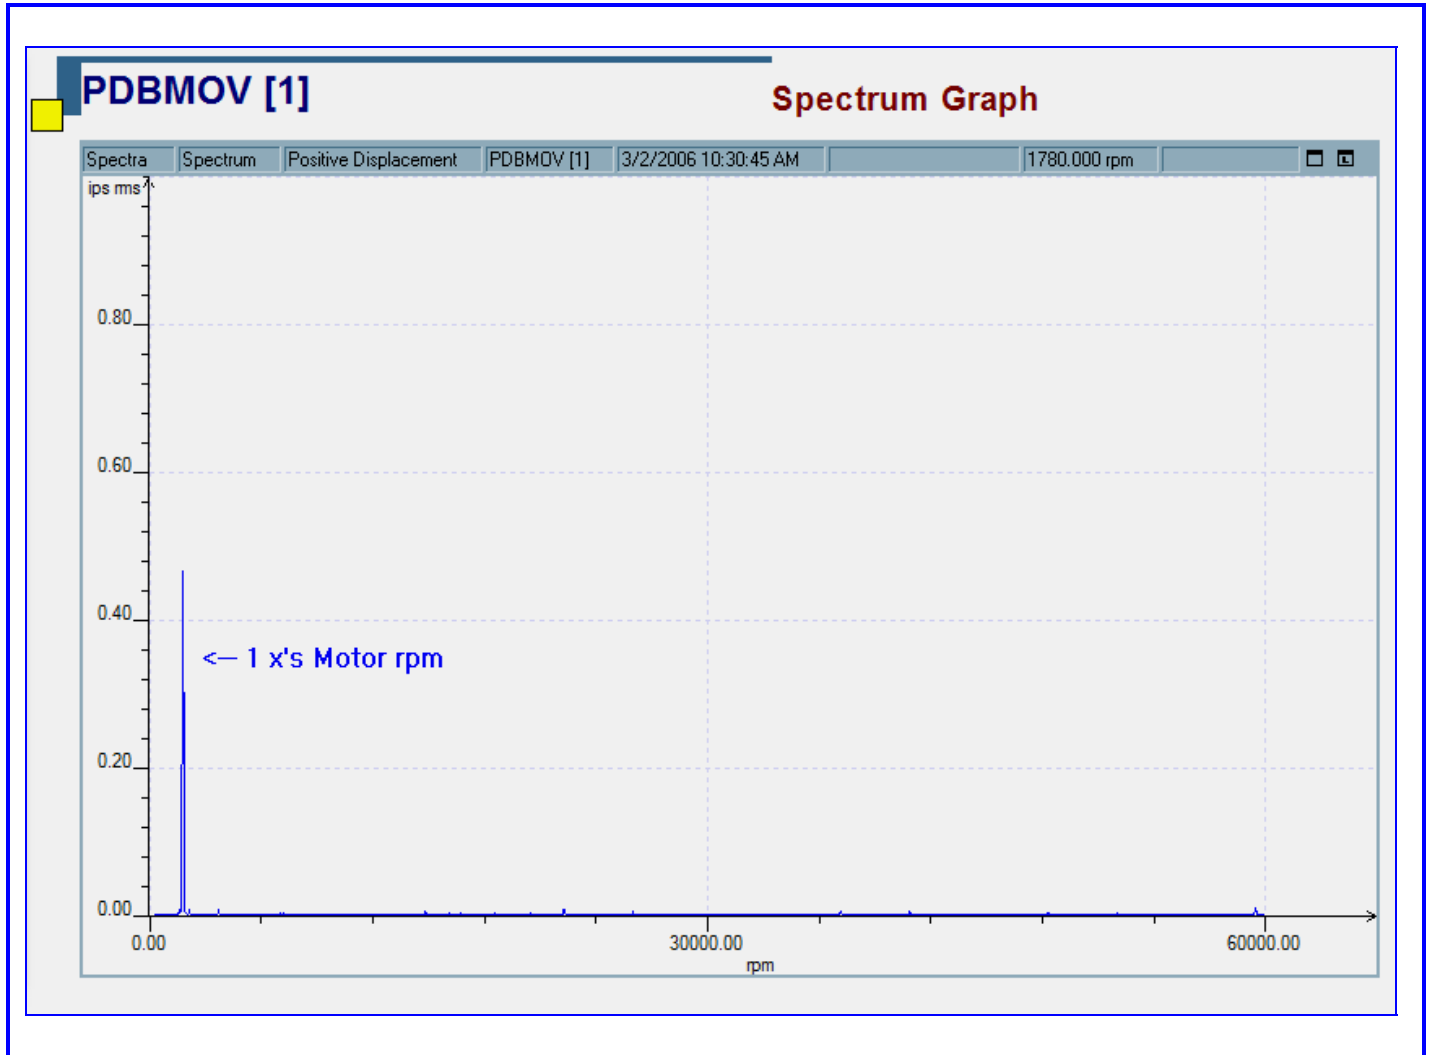
PDB POSITIVE DISPLACEMENT BLOWER

**High Motor Vibration Levels at 1 x's Motor rpm, Indicating Unbalance (See PDBMOV [1] Spectrum Graph and PDBMIV [1] Vibration Trend Graph)

- **Check for Eccentric Pulley
- **Recheck Motor Vibration Levels With Belts Removed
- **Periodic Monitoring
